IN RE: ETHICON, INC., PELVIC REPAIR SYSTEM PRODUCTS LIABILITY LITIGATION

**Master File No. 2:12-MD-02327**

## RULE 26 EXPERT REPORT OF HOWARD JORDI, PhD

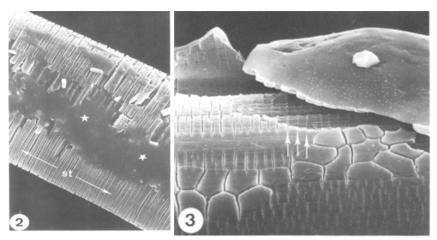
implantation "[b]oth prolene loops showed severe degradation of the surface layer."<sup>40</sup> The researchers characterize the morphological features on the surface of several explanted fibers and distinguish very well the different features of biological deposits compared to those associated with degraded Prolene polypropylene.

**Figure 1-** Prolene: Figure 2 (370×), degraded surface; \*=deposited organic matter; st=regular pattern of striations. Figure 3 (770×), detail of degraded surface layer. <sup>41</sup>

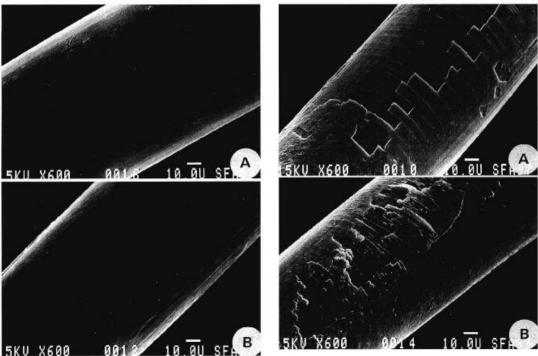
Figure 6. Scanning electron photomicrographs of retrieved and cleaned 6-0 polyvinylidene fluoride sutures showing the surface morphology after implantation for 1 (A,  $\times$ 600) and 2 (B,  $\times$ 600) years

Figure 7. Scanning electron photomicrographs of retrieved and cleaned 6–0 polypropylene sutures showing the surface morphology after implantation for 1 (A,  $\times$ 100) and 2 (B,  $\times$ 600) years *in vivo*.

After 1 and 2 years of implantation the surface of the retrieved and cleaned PVDF sutures did not appear to be substantially modified (fig 6). In contrast, the <u>polypropylene</u> <u>sutures explanted 1 and 2 years postoperatively showed evidence of surface deterioration, characterized by uniformly spaced circumferential cracking and <u>peeling and flaking of the polymer material in the outermost surface layer</u> (fig. 7) (emphasis added)</u>

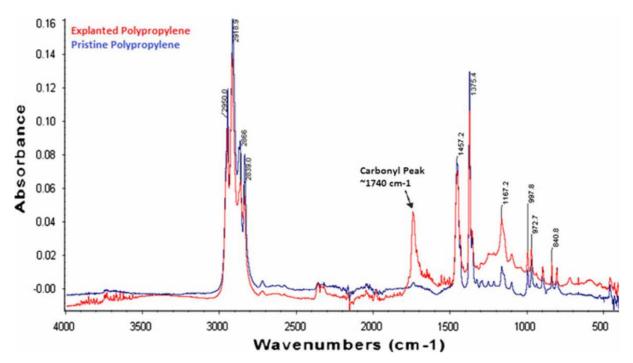
To determine why the polypropylene had cracked, these scientists used FTIR. Wood *et al.* concluded that the cracked surface of the explanted polypropylene mesh was caused by oxidative degradation as confirmed by the presence of a carbonyl band at  $\sim 1740 \text{ cm}^{-1}$ :

**Figure 6-** ATR-FTIR scans of pristine polypropylene and a representative polypropylene explant illustrating the carbonyl (C=O) peak.<sup>52</sup>

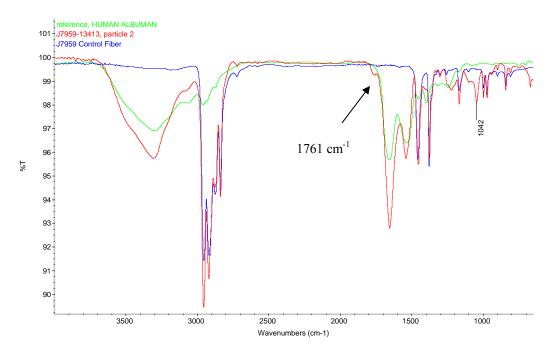
Similar to the FTIR findings in the Wood article, I have also found evidence that the Prolene in the TVT devices oxidizes which is the likely cause of the degradation and cracking observed on explanted TVT devices:

**Figure 7-** Overlay of FTIR spectra observed by me for explant sample 13413 particle 2 (red), human albumin (green) and control fiber lot 3422128 (blue).

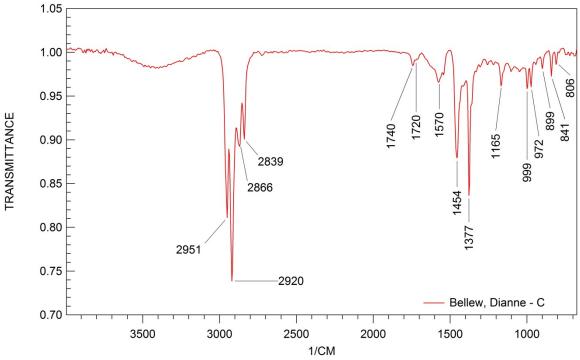
**Figure 8:** FTIR spectrum from an explanted Ethicon Prolift device which is also manufactured using Ethicon's Prolene polypropylene material – the same Prolene material used in Ethicon's Prosima and TVT devices (sample 35615 - C).

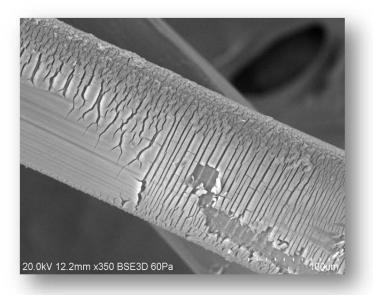
Figure 10- SEM image of explanted TVT device (Sample J7959 A13418)

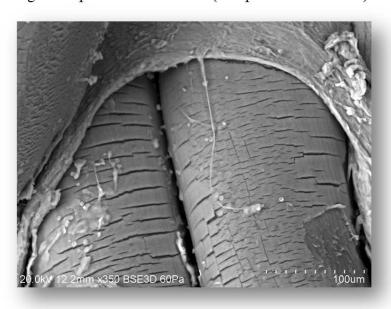
**Figure 11-** SEM image of explanted TVT device (Sample J7959 13405)

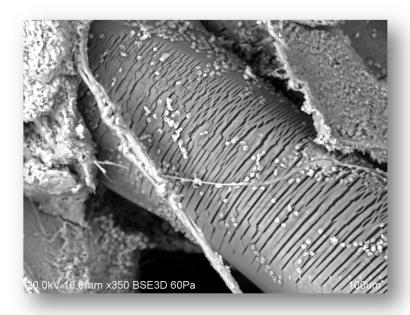
Figure 12- SEM image of explanted TVT device (Sample J7959 13407)

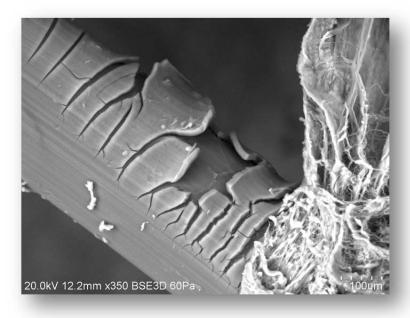
Figure 14- SEM image of explanted TVT device (Sample J7959 13409)

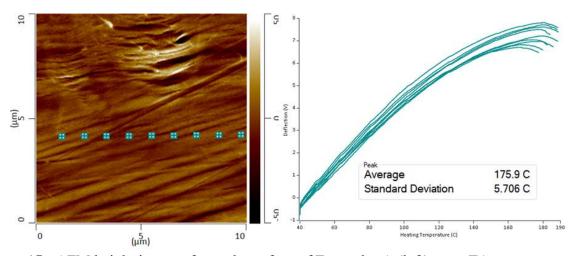
**Figure 15 -** AFM height image of sample surface of Exemplar A (left). nanoTA measurements obtained from surface of Exemplar A (right).

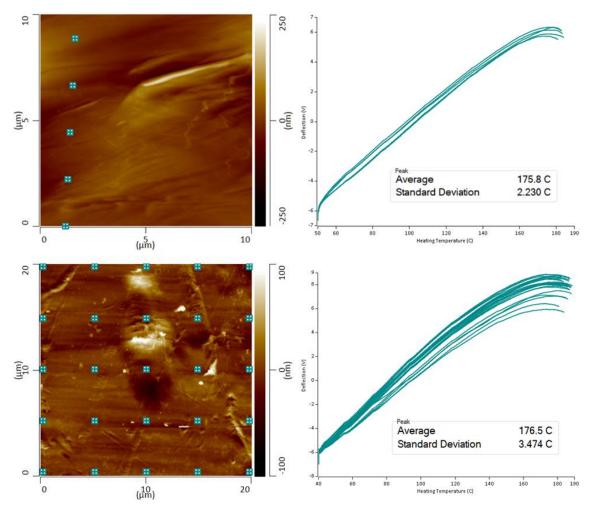
**Figure 16 -** AFM imaging of Exemplar C (markers on image indicate regions for subsequent nanoTA measurements (left). nanoTA measurements obtained on the surface of Exemplar C (right).

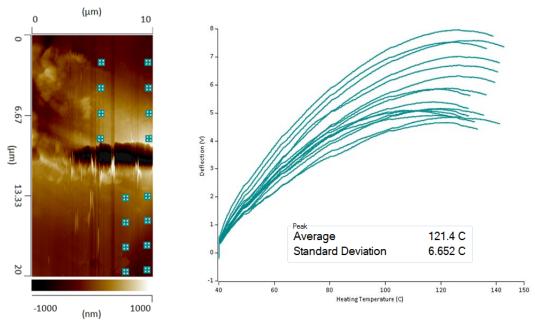
Ethicon's findings above are consistent with my own experience using melt point methods to analyze explanted Ethicon Prolene mesh devices. I have observed lower melt points using Nanothermal analysis which demonstrated that the explanted device degraded as a result of oxidation, which most likely occurred as a result of *in vivo* leaching of the antioxidants which leaves the Prolene fibers unprotected against oxidation.

**Figure 17 -** AFM image of cracked region on Bellew, Dianne B (left). nanoTA measurements obtained around cracked regions on Bellew, Dianne B (right).

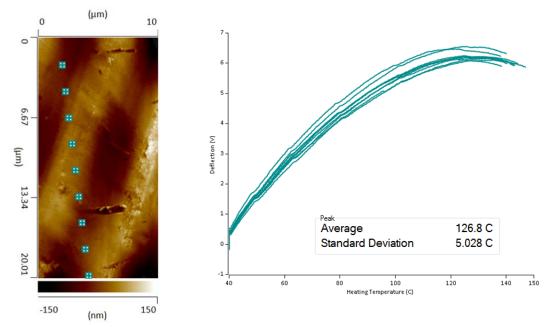
**Figure 18 -** AFM height image showing surface topography of Bellew, Dianne B fibers in region away from cracks (left). nanoTA measurements obtained away from the cracked regions on Bellew, Dianne B fibers (right).

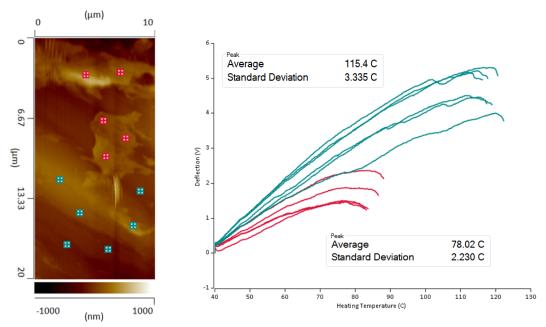
**Figure 19 -** AFM height image of surface of hypochlorite treated Bellew, Dianne C (left). nanoTA measurements on Bellew, Dianne C both on (red) and off (blue) the flake-like material (right).
